SPILL PREVENTION CONTROL AND COUNTERMEASURE (SPCC) PLAN

The University of Connecticut
Storrs Campus
Storrs, Connecticut

CDM Smith

July 2021 Amended September 2022

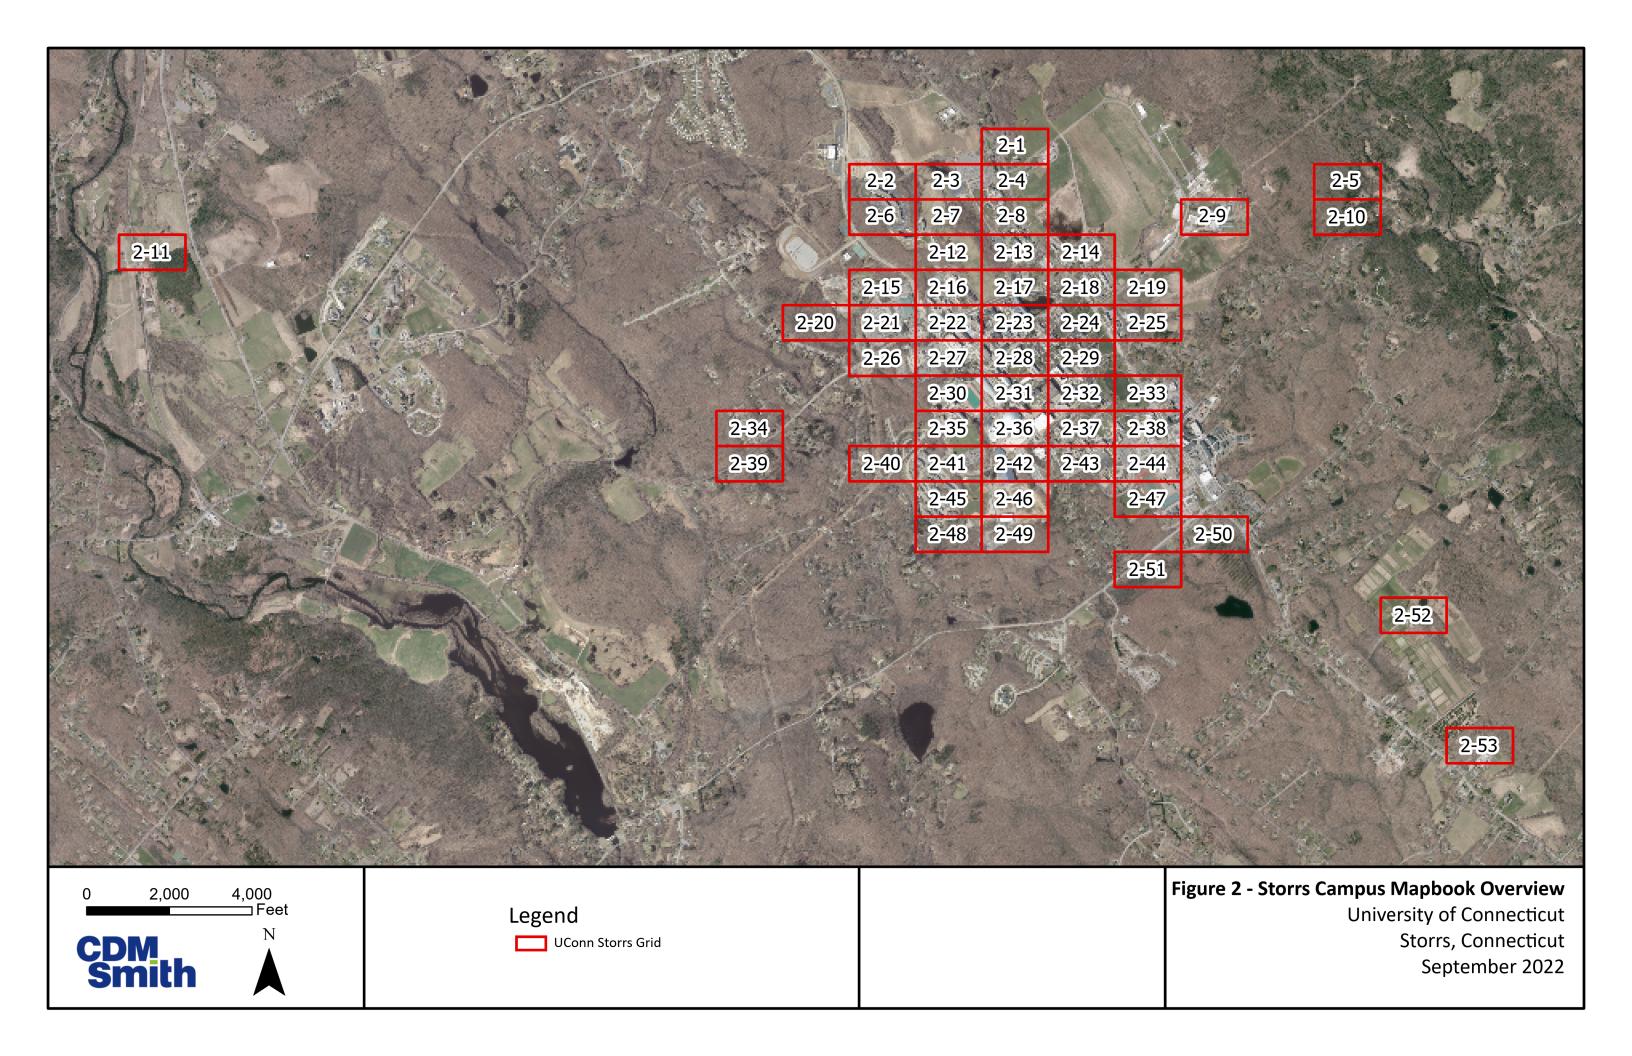
Figure 2 Storrs Campus Overview Map

Tank ID	Building/Container	Figure Number
	Aboveground Storage Tanks (ASTs)	
AST-35	Planning Design and Construction Warehouse	2-15
AST-36	Engineering/Castleman	2-28
AST-38	Gampel Pavilion	2-36
AST-46	IMS Building - 4th Floor	2-22
AST-47	IMS Building - Loading Dock	2-22
AST-48	Jorgenson	2-28
AST-50	Motor Pool	2-15
AST-51	Motor Pool	2-15
AST-53	Psychology	2-32
AST-55	Mink Barn	2-1
AST-56	South Campus Chiller	2-43
AST-57	Plant Science/Agronomy	2-52
AST-59	Plant Science/Agronomy	2-52
AST-63	Putnam Refectory Dining	2-35
AST-64	Student Union - Bistro	2-28
AST-65	McConaughy Dining	2-16
AST-66	Whitney Dining	2-25
AST-67	Gelfenbien (Towers) Dining	2-13
AST-68	NW Dining Hall	2-16
AST-69	Shippee Dining	2-33
AST-70	Buckley Dining	2-33
AST-72	McMahon Dining	2-42
AST-73	South Campus Dining	2-37
AST-76	WPCF	2-15
AST-77	Next to North Garage	2-27
AST-80	CUP	2-23
AST-81	CUP	2-23
AST-82	CUP	2-23
AST-02	Student Union, Union Street Café	2-31

AST-124	Planning Design and Construction Warehouse	2-15
AST-120 AST-127	Motor Pool	2-15
AST-127 AST-130	Public Safety Building	2-15
AST-131	Reclaimed Water Facility	2-20
AST-132	Willimantic Well Field	2-11
AST-133	Nextel Radio Tower	2-12
AST-134	Health Services	2-23
AST-135	Fieldhouse	2-31
AST-138	Student Union, Fire & Wok	2-31
AST-139	Student Union, One Plate Two Plates	2-31
AST-140	Ice Rink	2-49
AST-142	Motor Pool	2-15
AST-143	Engineering/Castleman	2-28
AST-144	High Head Lift Station	2-3
AST-145	Isolation Farm	2-53
AST-147	Gurleyville Lift Station	2-19
AST-148	Willimantic Well Field	2-11
AST-149	Mobile Supply Fuel Truck	2-21
AST-150	Supplemental Utility Plant	2-26
AST-151	Supplemental Utility Plant	2-26
AST-152	Farm Services	2-9
AST-153	Hockey Arena	2-48
AST-154	Public Safety Building	2-22

Tank ID	Building/Container	Figure Number	
	Underground Storage Tanks (USTs)		
UST-3	Mansfield Apartment Lift Station	2-50	
UST-10	Beach Hall	2-24	
UST-13	Biology #4 - Horsebarn Hill	2-9	
UST-14	Commissary	2-25	
UST-15	Dodd Research Center	2-32	
UST-16	Eastwood Lift Station	2-51	
UST-18	Fenton Well Field	2-5	
UST-20	CUP	2-23	
UST-21	CUP	2-23	
UST-22	CUP	2-23	
UST-23	CUP	2-23	
UST-24	CUP	2-23	
UST-25	CUP	2-23	
UST-28	Outside Motor Pool	2-15	
UST-29	Outside Motor Pool	2-15	
UST-32	Northwood Apartment Lift Station	2-34	
UST-35	Plant Science	2-52	
UST-36	Plant Science	2-52	
UST-39	Psychology Building	2-32	
UST-40	Isolation Farm	2-53	
UST-41	Isolation Farm	2-53	
UST-45	WPCF	2-15	
UST-46	WPCF	2-15	
UST-52	Supplemental Utility Plant	2-26	
Drum Storage Areas			
D-1	Motor Pool	2-15	
D-2	Sludge Pump Bldg/Garage at WPCF	2-15	
D-3	SHT Bldg at WPCF	2-15	
D-4	Planning Design and Construction Warehouse	2-15	
D-5	Farm Services	2-9	
D-6	Plant Science - Lab Area	2-52

D-7	Plant Science - Workshop Area	2-52

numbers consist of an abbreviation for the type of tank followed by a number. UConn's tank numbering is not sequential, as some tanks listed in previous SPCC Plan versions have been removed or re-located to a different UConn Campus. The Campus Overview Map (**Figure 2**) and accompanying table show the individual tank ID and referenced figure number.

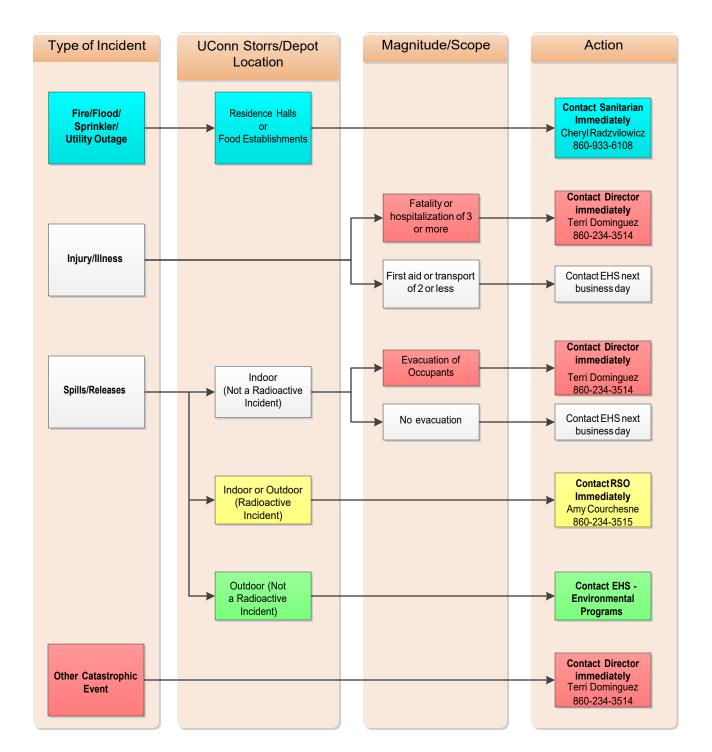
UCONN EMERGENCY SPILL PROCEDURAL FLOW DIAGRAM

Public Safety/EHS After-hours Communication Decision Tree
