# SPILL PREVENTION, CONTROL, AND COUNTERMEASURE (SPCC) PLAN

University of Connecticut Depot Campus Mansfield, Connecticut

## SPILL PREVENTION, CONTROL, AND COUNTERMEASURE PLAN UNIVERSITY OF CONNECTICUT, DEPOT CAMPUS FACILITY INFORMATION

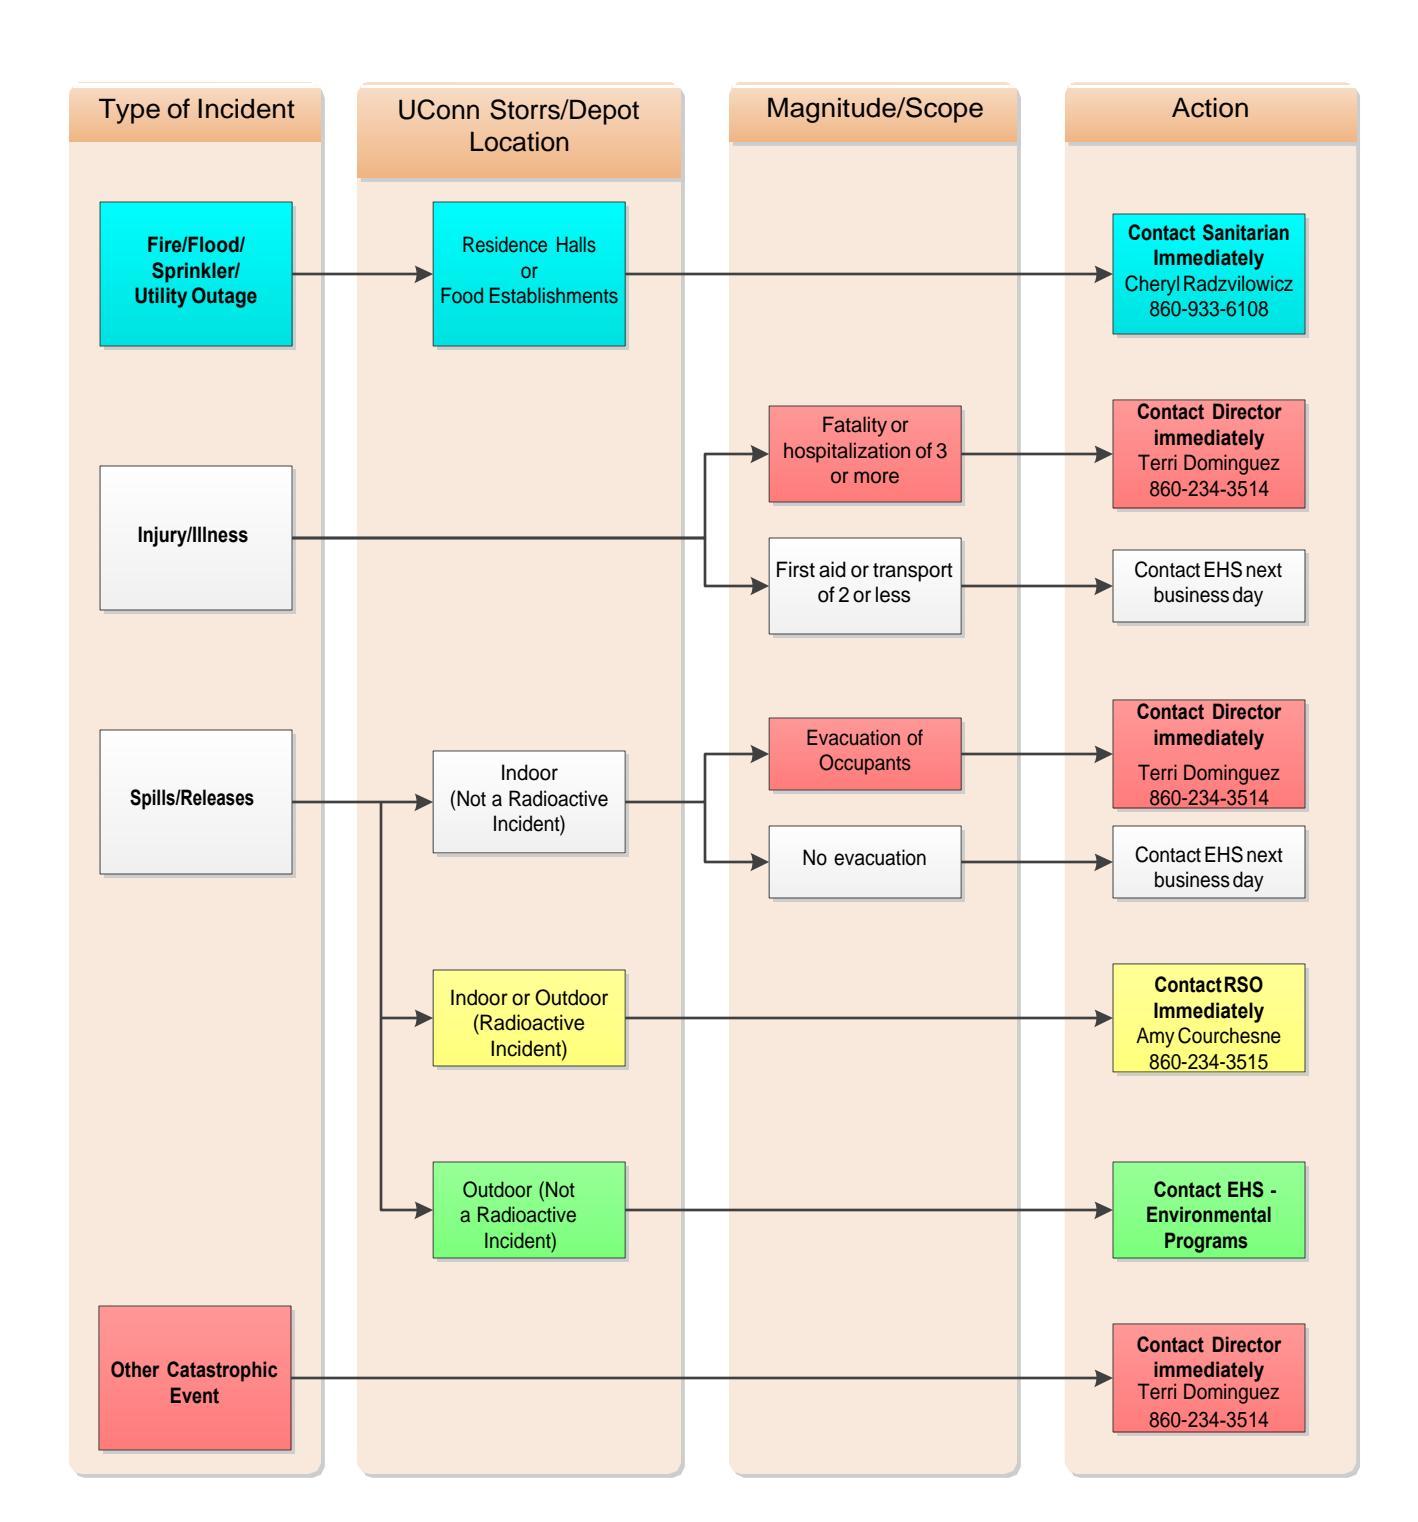
UCONN EMERGENCY SPILL RESPONSE PROCEDURAL FLOW DIAGRAM

# Public Safety/EHS After-hours Communication Decision Tree

Additionally, a copy of the Public Safety/EHS After-Hours Communication Decision Tree can be found in
